A No-Litigation Solution To A Failing Large Retaining Wall

Unstable SRW Retaining Wall at Carver High School

Location: Columbus, GA

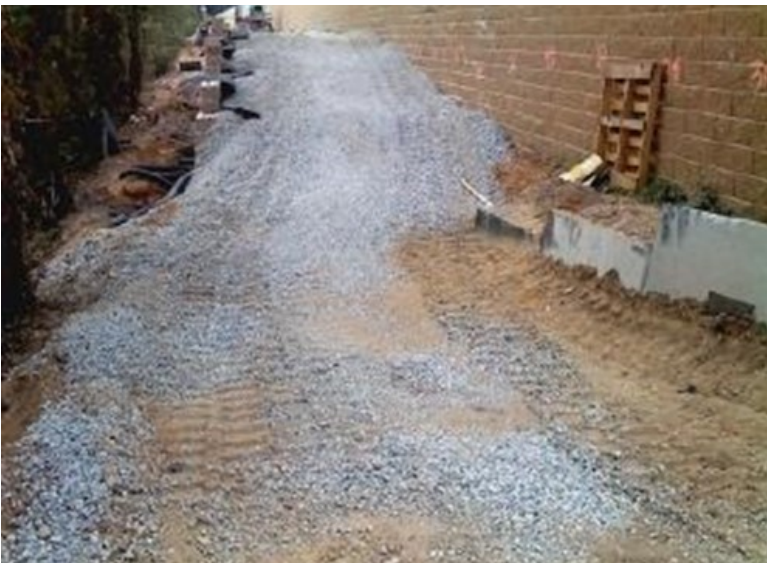
Start of the new buttress wall and temporary shoring

The 10-to-29-foot tall toe-buttress wall was constructed to improve the internal stability of the original lower tier MSEW. Site geometry and soil conditions required small height excavation support, consisting of discreet concrete panels stabilized by a single 54-kip capacity soil nail, be used beneath the existing original MSEW construction to ensure safe working conditions for construction of the toe-buttress wall.

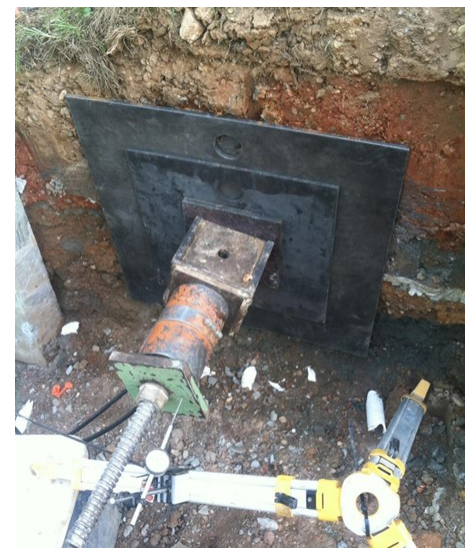
Nail Testing & Lock-off
